May 5, 2017 city water pressure drop

By Matt McBride, October 27, 2017

Introduction

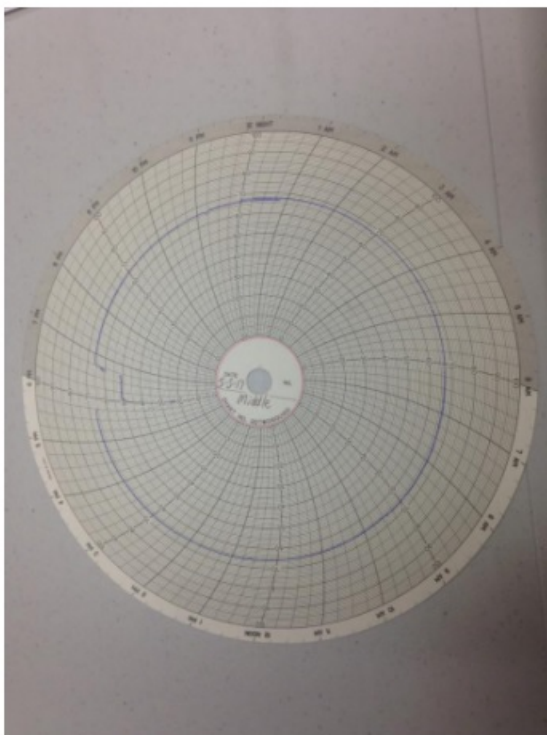
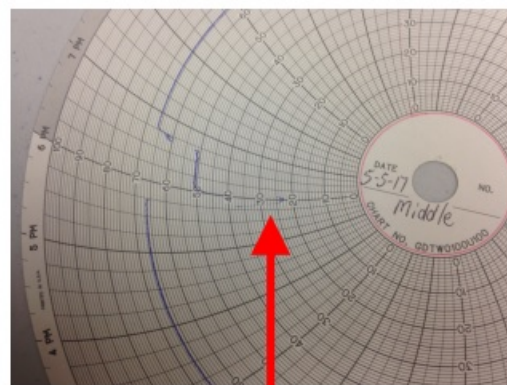
May 5, 2017 chart from High Lift city water pressure chart recorder

Around 5:40 PM on May 5, 2017, both water distribution pumps A and B at the Sewerage and Water Board powerhouse shut down unexpectedly. With the loss of the pumps, city water pressure fell from 66 psi to approximately 23 psi as measured at High Lift on the Carrollton Water Plant. City water pressure is recorded, among other places, on a chart recorder in the High Lift control room:

City water pressure drop due
to loss of A and B pumps

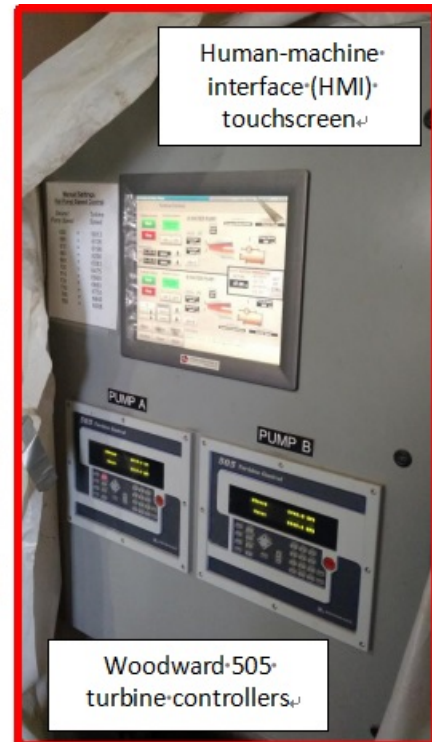
Control cabinet for pumps A and B

According to interviews with senior powerhouse staff, the cabinet is powered off a 60 cycle alternating current feed with backup direct current power off the powerhouse batteries. Unbeknownst to staff, at some point prior to May 5, 2017 one of those power sources had failed. According to staff, the panel never alarmed on this condition because of a programming error. When the second power source to the cabinet failed, it took down everything controlled by the cabinet: both pumps A and B. This is what the 6:17 PM note in the Central Control logs was referring to:

Recommendation 2: Provide separate power supplies for each turbine controller for A and B pumps. Each should also be backed up independently, and each should have its own HMI to prevent errors. Also, alarms from each HMI should be sent out beyond the pump room. These changes could be incorporated into the boiler room upgrade project which will be kicking off soon.

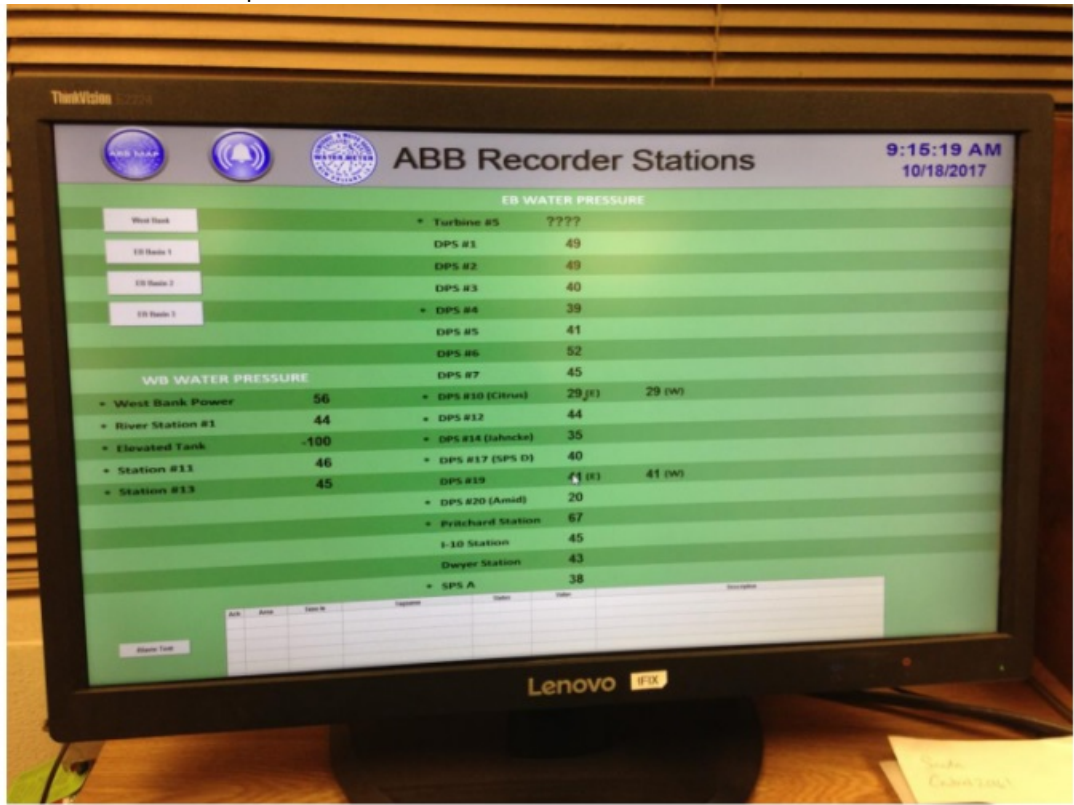
Central Control SCADA water pressure monitor screen

of Central Control's screen are the question marks next to the "Turbine #5" label. This indicates a loss of power to the instrument measuring water pressure at that location. This was explained by work proceeding on turbine #5 the day the photo was taken. Other differences are noted elsewhere in this report.

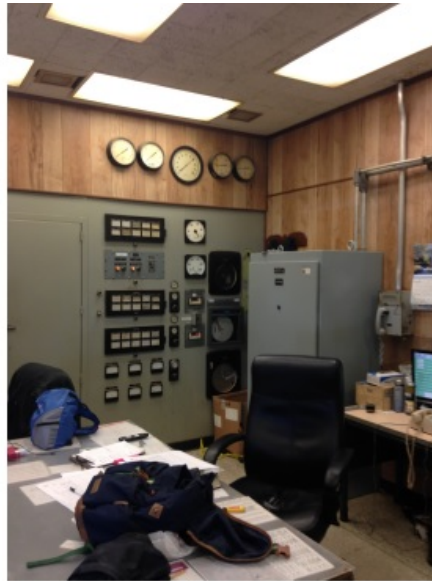
High lift control room in SWB powerhouse: low water pressure alarm sounds from wall with gauges

Powerhouse staff and operators report there are no visible strobes or lights throughout the powerhouse to indicate a low water pressure condition. In addition, the audible low water pressure alarm can only be heard in the High Lift control room. Note that every hour, the High Lift operator is out of the control room to perform rounds, which can take between 15 and 30 minutes. Outside of the hours of 7 AM and 3 PM, when a trainee helper might be in the room, it is possible the High Lift control room could be unoccupied for 15 to 30 minutes of every hour.

Recommendation 4b: Expand notification of low water pressure alarms throughout the powerhouse to include strobes or horns to allow personnel to be alerted from any location to such an alarm.

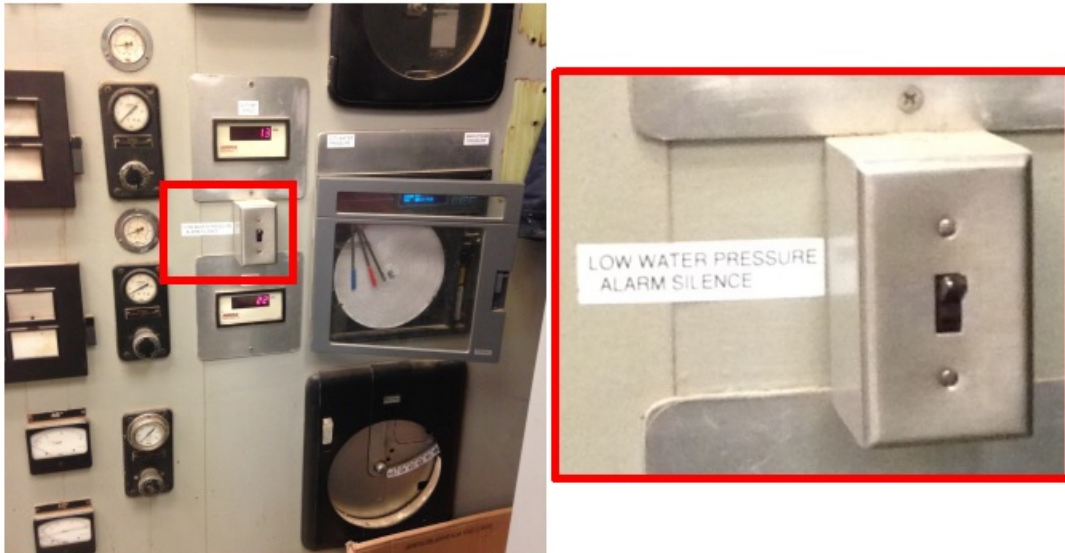
High Lift control room in SWB powerhouse: low water pressure alarm silence switch highlighted

This switch does not resolve the alarm condition, it only turns the noise of the alarm off. The switch is of a design identical to a household light switch: once the alarm silence is activated, it can remain in that condition until turned off. There does not appear to be any timer or other control to dismiss the silence after a time or resolution of the alarm condition.

Recommendation 4a: Remove the low water pressure alarm silence switch in the High Lift control room.

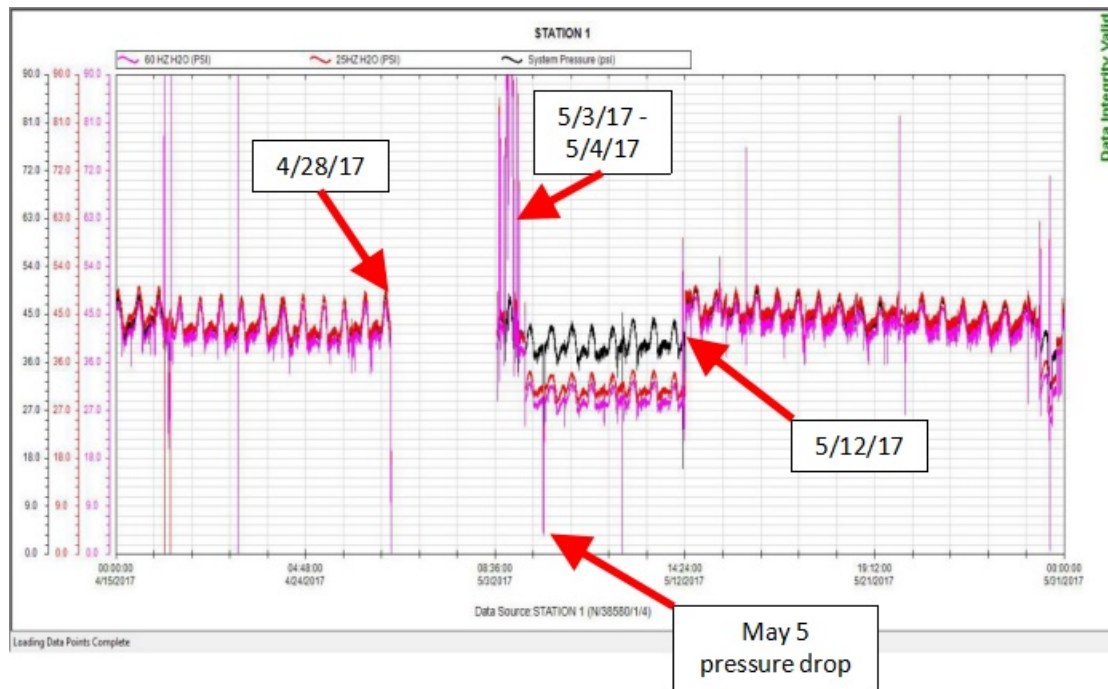
DPS #1 water pressures from 4/15/17 to 5/31/17: 60 Hz (purple), 25 Hz (red), system (black)

First, between April 28 and May 3 data archiving was offline. DPS #1 was not the only station struck by this problem. DPS #10 in New Orleans East experienced an identical loss of archiving of pressure transmitter data during the same timespan. The cause is unknown.

Second, on May 3 and May 4, the pressure data was extremely volatile. This volatility was observed in the SCADA systems at other stations such as DPS #5 during the same two day period. The cause is unknown at this time.

Finally, during the period from May 4 to May 12, "system pressure," which as an average should be between the other two pressures, instead registered significantly higher than both. Also, the values for 60 Hz H2O and 25 Hz H2O ran quite a bit lower than normal. Both these conditions argue against good quality data between May 4 and May 12.

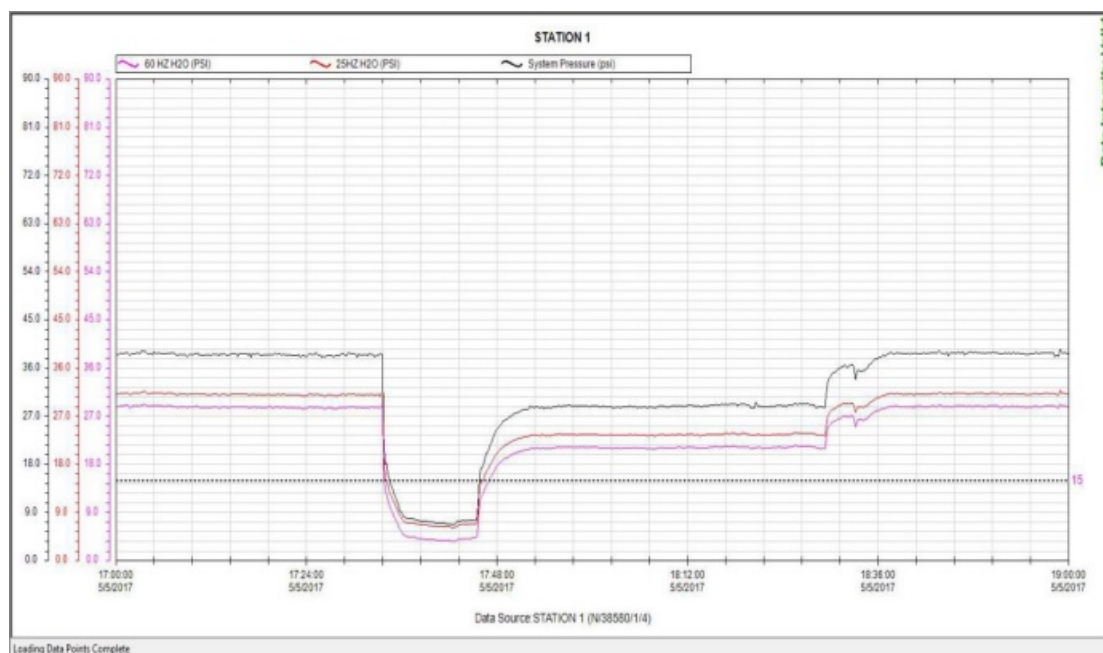
DPS #1 water pressures from 5 PM to 7 PM on 5/5/17: 60 Hz (purple), 25 Hz (red), system (black)

But - and this is important - it is unclear if all this detail was known at the time to Sewerage & Water Board senior staff and decisionmakers. At the time of the May 5, 2017 water pressure loss, all three parameters fell significantly below 15 psi (represented by the dotted line across the chart):

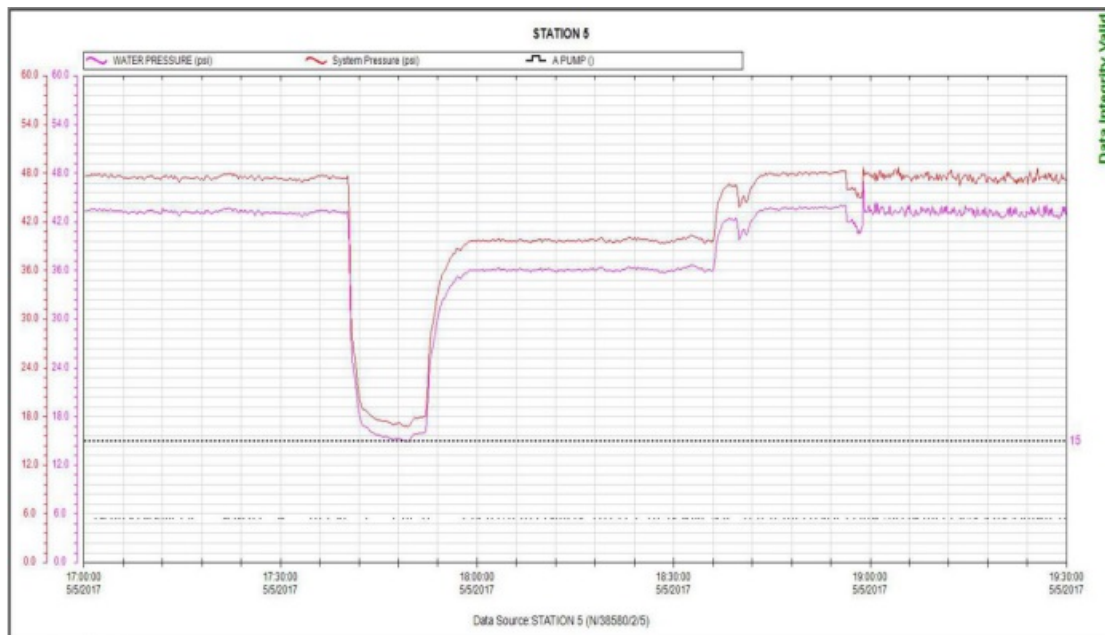
DPS #5 water pressure (purple) and system pressure (red) on May 5, 2017, 5:00 PM to 7:30 PM

As such, the data for May 5 at station 5, including the drop of city water pressure below 15 psi, appear to be valid and reflective of city water pressure outside the station.

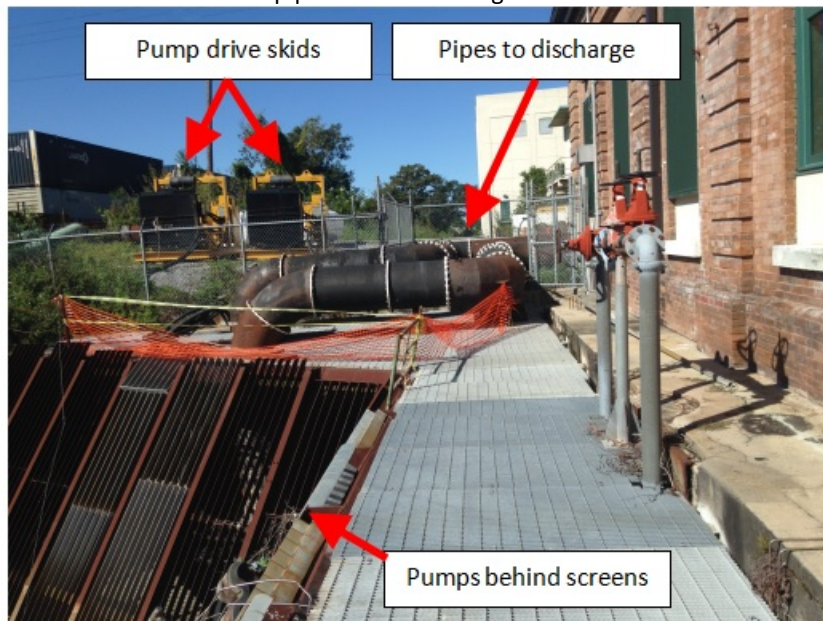
The likely reasons for this difference - that is, the much lower pressure on the "water pressure" side of the system - are the massive water leaks on the shaft seals of both constant duty pumps. These seals are fed from the "water pressure" line. The leaks are so huge that the constant duty pump pit has water to a depth of a few feet in it, and a sump pump is permanently pumping water out of the pit and into the suction basin. Video of the pit when inundated is available here:

DPS #7: Temporary pumps to make up for capacity loss during constant duty pump repairs

Plans call for refit of at least one of the constant duty pumps to fix this problem. To make up for the loss of pumping capacity during the refit, two temporary hydraulically-actuated axial pumps have been placed in the suction basin and piped to the discharge basin:

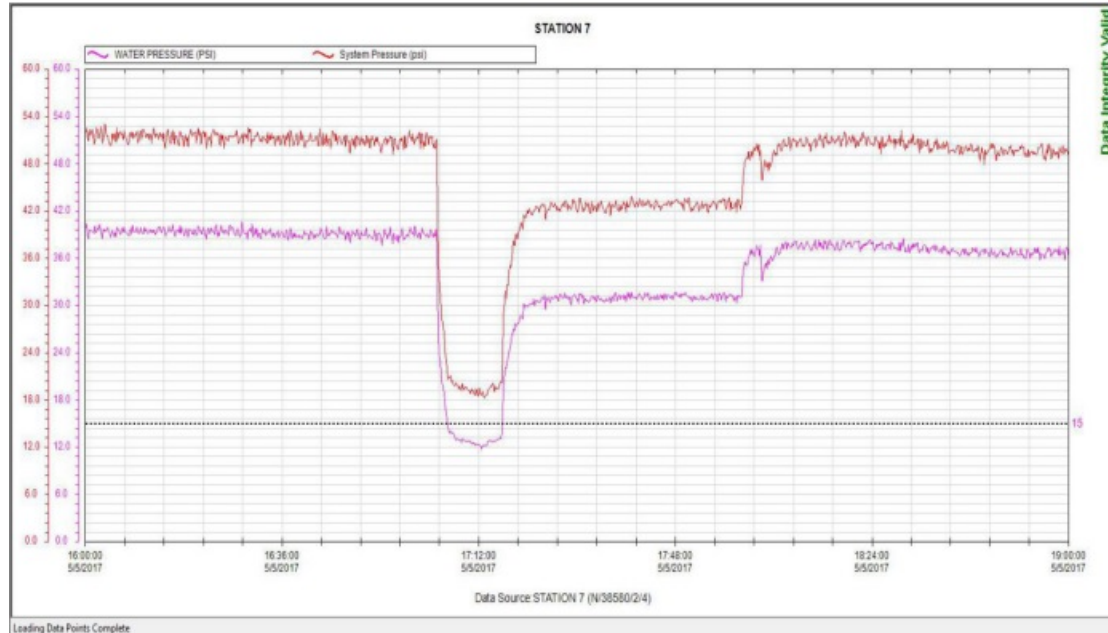
DPS #7 water pressure (purple) and system pressure (red) on May 5, 2017, from 4 PM to 7 PM

However, until those repairs take place, the "water pressure" side of the station water system will have a pressure below the actual local city water pressure. It is possible it is as much as the current difference - about 10 psi.

it was more a reflection of the location of the "water pressure" transmitter combined with the constant duty shaft seal leaks, and less a reflection of a local city water pressure reaching below 15 psi.

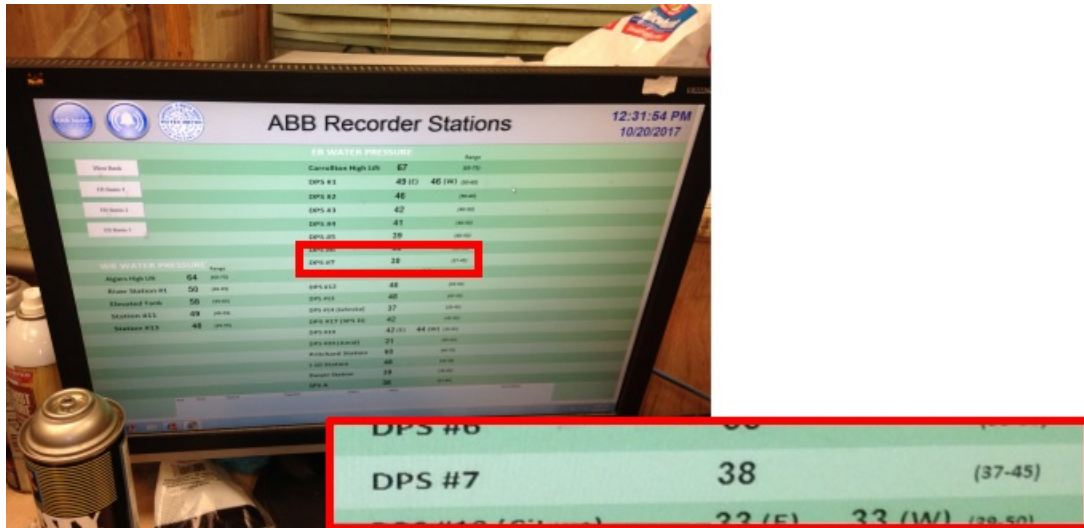
Interestingly, the DPS #7 pressure chosen for display on the High Lift SCADA screen appears to be the somewhat inaccurate "water pressure." We know this because of the reading shown in the photo (38 psi, verified against the SCADA data collected at the time of the photo), and the acceptable range shown next to it (37-45 psi, which is the normal range for "water pressure" at DPS #7):

DPS #7 "water pressure" shown on High Lift SCADA display

Recommendation 3: Assign an engineer to do a complete survey of all water pressure monitoring points throughout the system and all SCADA displays which collect the data. Compile findings for submission to the Interim Emergency Management Team within 15 days. Correct any deficiencies such as use of non-representative data, mistaken labeling, and lack of consistency from display to display. Implementation or scheduling of implementation of fixes should be complete by the time of the I-Team's departure on November 30.

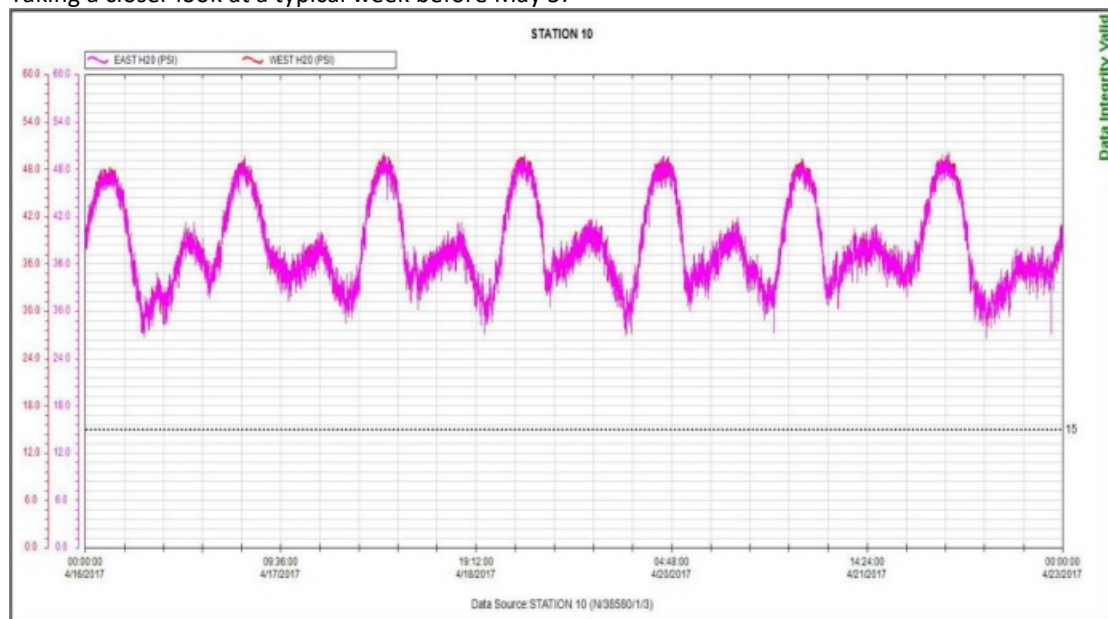
DPS #10 East H2O (purple) and West H2O (red) from 4/16/17 to 4/23/17

As one can see, there is near total overlap between the East H2O and the West H2O readings. Also notable are the relatively low pressure readings, typically hovering around the high 30's or low 40's depending on the time of day. A survey of Fridays leading up to May 5 shows typical pressure readings at 5 PM of about 37 psi. On May 5, the pressure at 5 PM was 36.0 psi for East H2O and 36.6 psi for West H2O, or completely normal. A site survey of the station showed agreement on a local pressure gauge with the transmitted value for West H2O. There do not appear to be any serious water leaks at the station which would drag the pressure down.

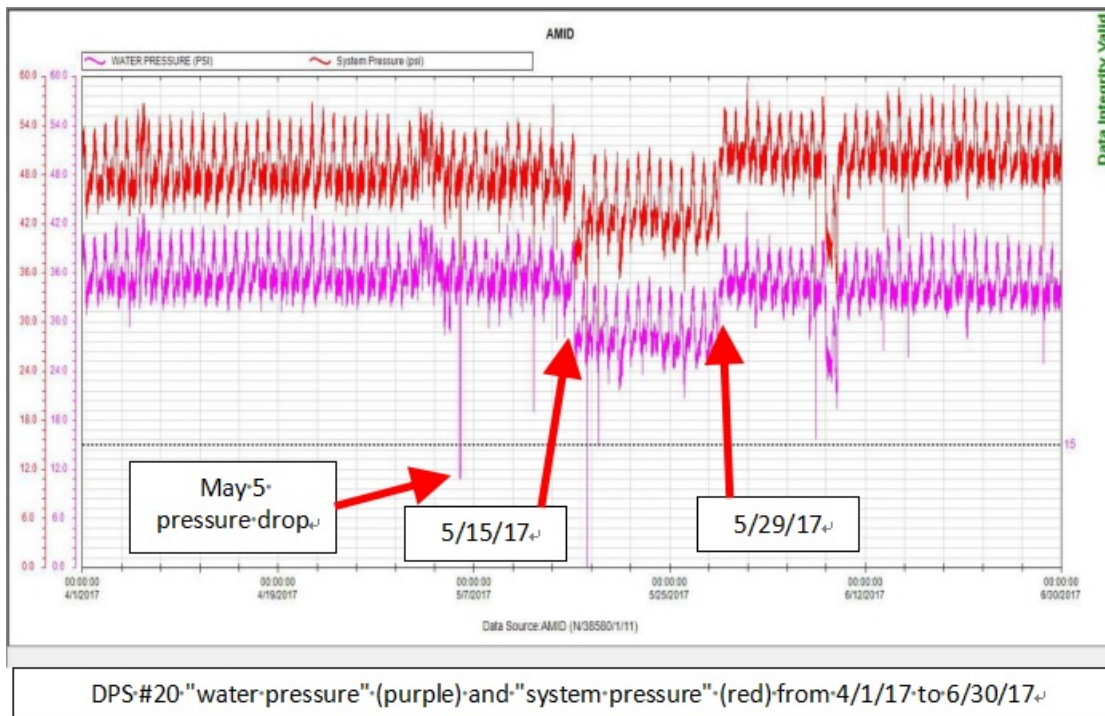
As noted above, the pressure transmitter for "water pressure" historically reads much lower than that for "system pressure:"

The chart for DPS #20 exhibits some of the same problems as other stations. There was a sharp drop in water pressure on May 15 which was not recovered until May 29 (nearly the same timespan as for DPS #5 and DPS #10). Also, while not as prominent as at other stations like DPS #7, there appears to have been volatility in the pressure readings on May 3 and May 4. Neither of these problems were in effect on May 5.

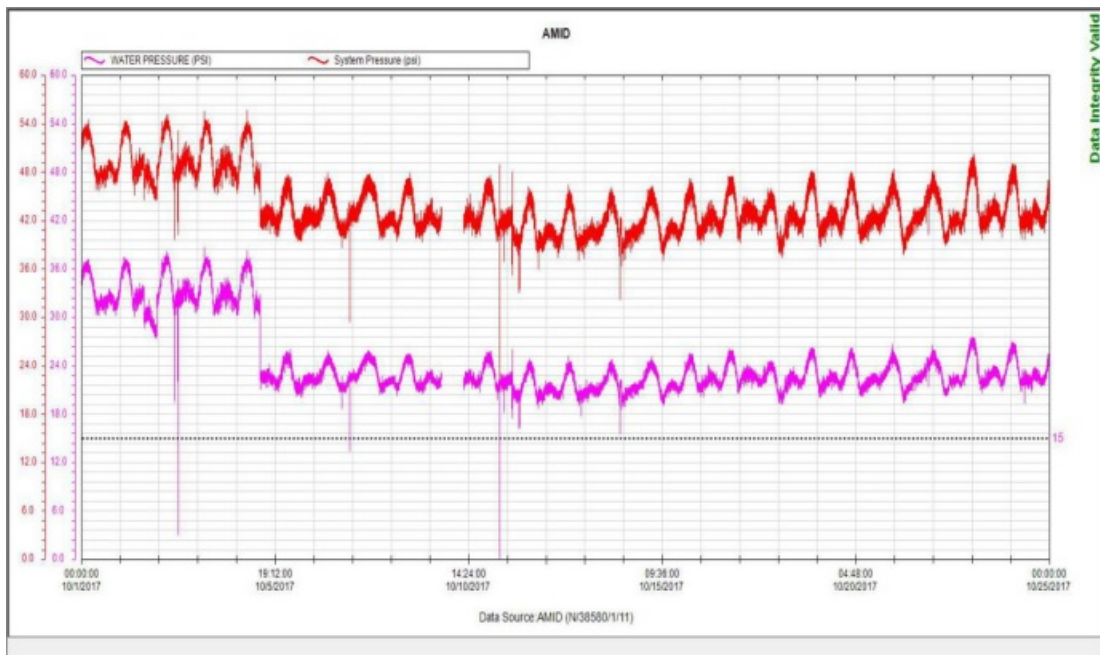
DPS #20 "water pressure" (purple) and "system pressure" (red) from 4/1/17 to 6/30/17.

But the distinguishing characteristic of the pressure readings at DPS #20 is the diminished pressure read by the transmitter labeled "water pressure." This section of water piping directly feeds the water seals on the two drainage pumps. The "system pressure" leg feeds something else, probably the control room facilities. I can only surmise there is a substantial leak somewhere in the "water pressure" portion of the system, or the pressure in that section is being kept artificially low. When the station was visited in late October, pressure on the "water pressure" portion of the system was running even lower than in the spring: in the low 20's. The pressure had been that low since early October, when it dropped at the same time as "system pressure:"

While it is conceivable that the city water pressure from the "water pressure" leg into the station is actually in the low 20's, it seems unlikely. 22 psi is hardly enough pressure to do anything, and one has to wonder if it is truly adequate for the station's needs, especially the pump that was recently repaired under a Board emergency declaration.
